AVIATION INVESTIGATION REPORT

A03Q0092

COLLISION WITH WATER

BELL 206 JET RANGER (HELICOPTER) C-GNPI

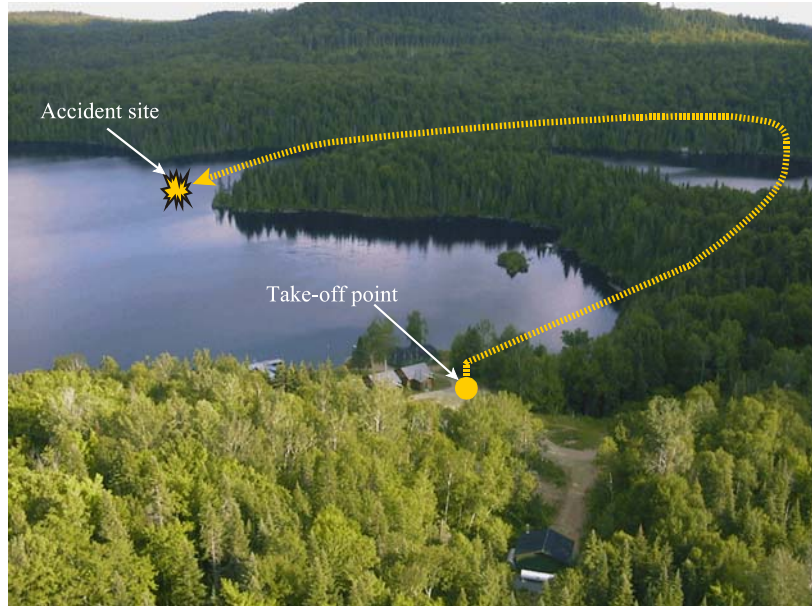
The meteorological conditions were suitable for visual flight, and the winds were calm. The pilot took off from the outfitter's parking at Boucher Lake, where four passengers had disembarked from the helicopter 30 minutes before. At a height of approximately 100 feet above ground level (agl), the helicopter commenced its flight in a south-westerly direction. When the aircraft reached translational speed, the pilot noticed that the power turbine rpm (N_2) and rotor rpm (N_r) had decreased from 100 per cent to 95 per cent and were

Photo 1. Estimated track of helicopter

still decreasing. However, he did not hear the low rpm warning alarm. To reduce power demand and increase rotor rpm, the pilot lowered the collective and at the same time lowered the nose to accelerate. A short time later, the N_2 indicator showed 85 per cent. The pilot, who was then over trees, steered the aircraft toward Boucher Lake, which was on his left. The aircraft descended over the lake and curved around a peninsula. After flying a distance of about one kilometre, a few feet above the lake, the pilot observed an increase in engine rpm in the normal operating range. However, he concluded that, because of the attitude, speed and altitude of the aircraft, the accident was unavoidable. The pilot raised the nose of the aircraft just before striking the surface of the water. Some of the outfitter's residents rescued the pilot a few minutes after the accident.

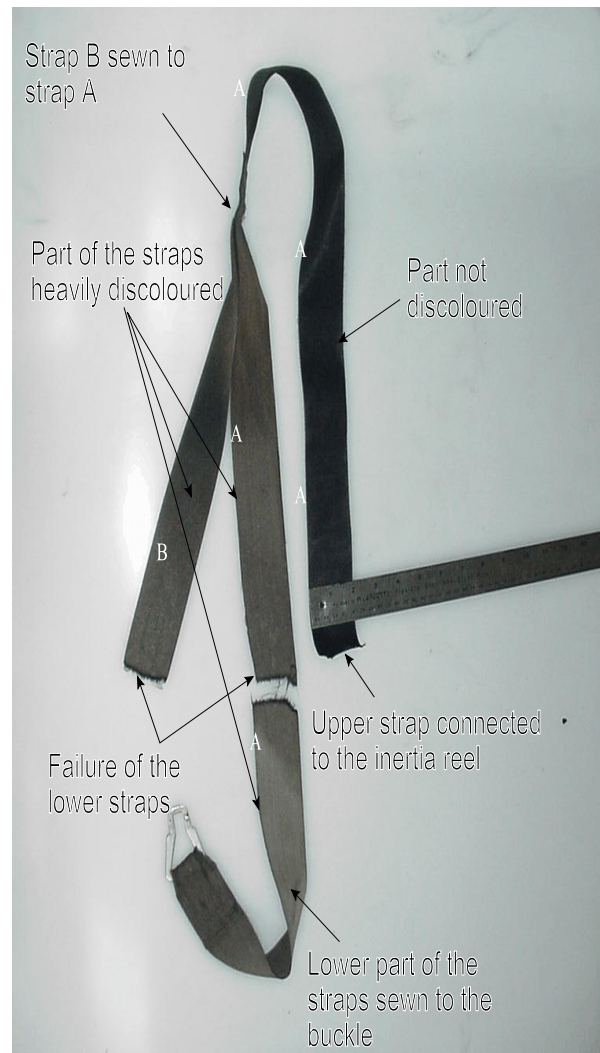
The pilot was wearing his seat belt, which consisted of a lap belt and shoulder straps connected to an inertia reel mounted on the back panel of the pilot's seat. As a result of the impact, the shoulder straps failed in overload. However, the lap belt remained intact. The pilot unfastened his seat belt before evacuating the helicopter. Although he was wearing a helmet, the pilot sustained substantial head injuries. Examination of the seat belt by the TSB Engineering Laboratory revealed that the shoulder straps were substantially discoloured. There were no signs of rubbing wear or tension. The thickness of the straps was relatively uniform. No date of manufacture was indicated on the shoulder straps; a label on the lap belt indicated that it was manufactured in December 1976. Strength testing established that the upper part of the strap failed under 1500 pounds of tension and the lower parts failed under 600 pounds. The applicable standard, Federal Aviation Administration (FAA) TSO C22, states that a strap two inches in width has a nominal strength of 1500 pounds and should not fail below 2250 pounds of tension. Seat belts are replaced when they are deemed to be in bad condition. Discolouration is not a criterion for belt replacement. According to the Bell Helicopter's company maintenance manual, proper operation, anchor security and the state of deterioration of belts should be checked on the 100-hour inspection.

Photo 2. Pilot's shoulder harness straps

The whitening of the lower shoulder straps was caused by ultraviolet rays from the sun. The upper part of the shoulder straps, which was less exposed to sunlight because it was rolled up on the inertia reel, was practically not faded. Since the lower parts of the straps failed at 600 pounds of tension and the upper portion failed at 1500 pounds, it is reasonable to conclude that the degree of weakening of the straps corresponded to the duration of their exposure to sunlight. Moreover, since the upper portion of the strap, although less exposed to sunlight, failed at 66 per cent of the limit required by standard TSO C22, it is reasonable to conclude that even a strap exhibiting no signs of discolouration may have sustained some ultraviolet degradation. Since their mechanical strength was reduced to about 26 per cent of their original strength, the lower shoulder straps failed before reaching the prescribed limit. Consequently, the pilot was subjected to greater deceleration forces than he should have sustained in the accident. The degree of discolouration of the lower shoulder straps was indicative of a degradation of

their strength. However, since no signs of physical wear were found, the belts were considered to be in good condition on the aircraft maintenance and TC inspections. It appears therefore that the absence of specific evaluation criteria with regard to the ultraviolet degradation of the belts contributed to the return to service of seat belts that no longer met regulatory requirements.

1. The pilot's seat belt shoulder straps failed at a tension level below regulatory requirements. The failure occurred as a result of degradation of the straps caused by prolonged exposure to sunlight.
